The Office of the
Fire Marshal
Bureau du
Commissaire des Incendies

Fire Investigation Services

Confidential Fire Investigation Report Investigation No.: 218-011-2022

Investigation No.: 218-011-2022
Occurrence Date: 17-Jul-2022
Alarm Time: 18:07:00
Street. #: 19
Street: Courtice Crt.
Apt. #:
City: Clarington
Municipality: Clarington
Province: ON

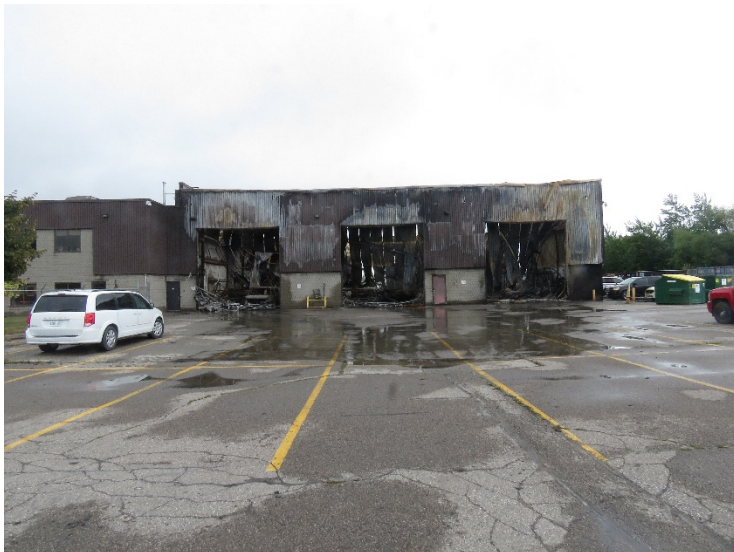
Front of the section of the building where the fire originated

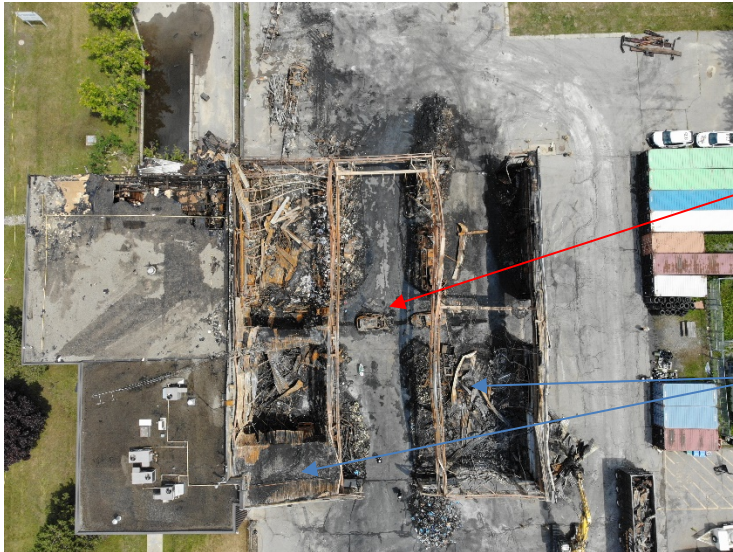
Complete collapse of the roof towards the centre portion of the building which aligns with where fire personnel witnessed largest volume of fire

Residual pieces of metal clad of the roof structure

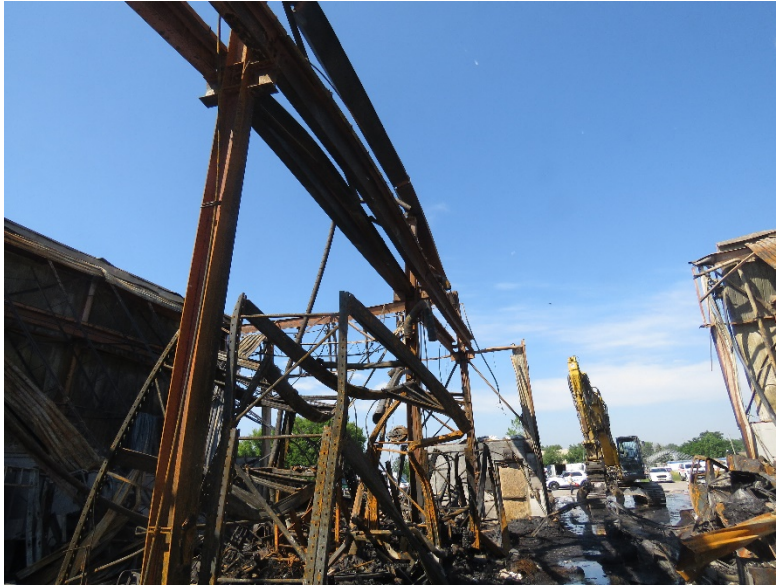
Metallic structural components depicting its warping and deformation towards the centre section. Fire effects in contextual analysis refutes alternate area of origin hypotheses

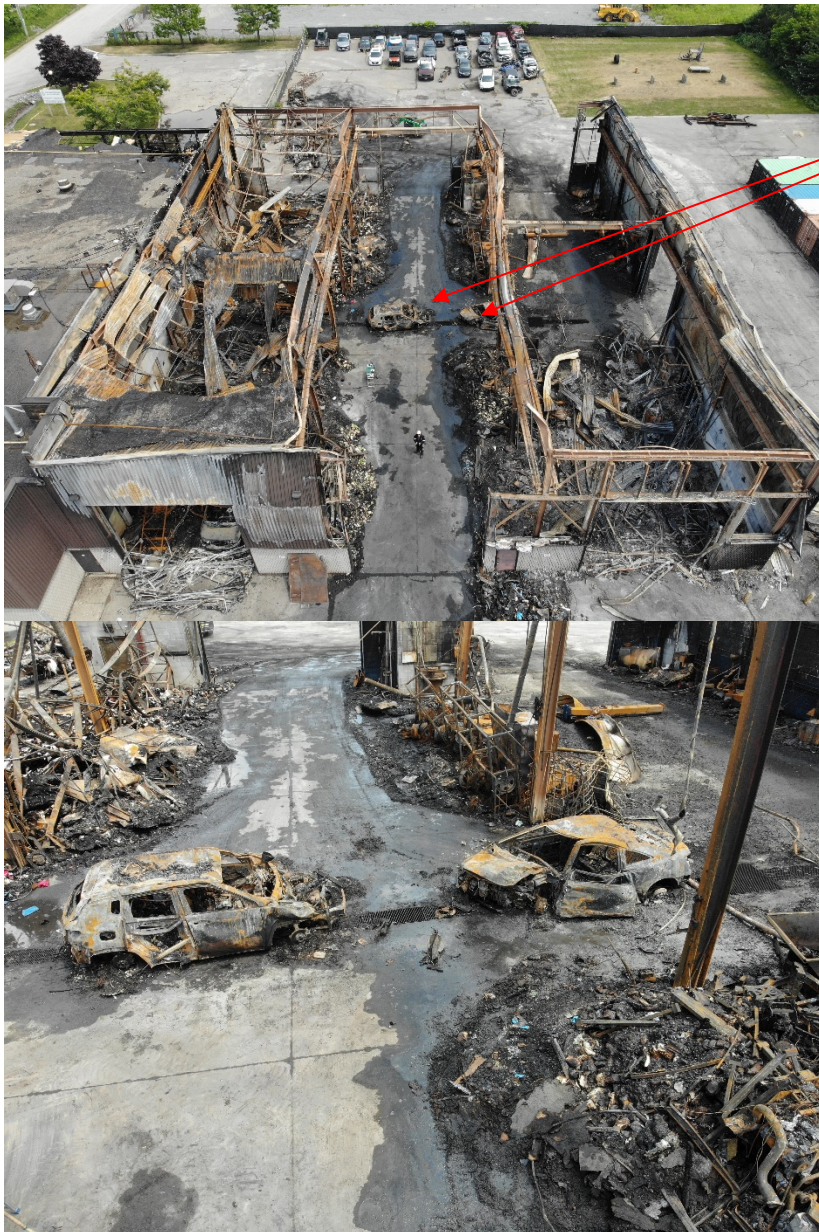
Two vehicles recovered
underneath the collapsed
sections of the roof and
structural components

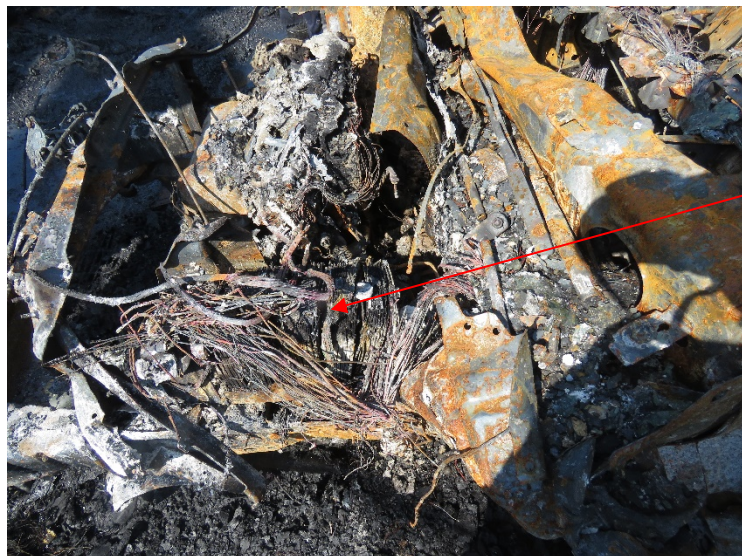
Localized impact in
the area of the
battery in a vehicle

3. The vehicles were involved in a head on collision which resulted in impact towards the driver's side of both vehicles and the specified area that contained the power source (battery and accompanying components). Forensic engineering surveyed the area and recovered portions of the conductors to the battery on the Jeep, as well as evidence of arcing on the residual sections of conductors. The battery and the accompanying components of the Honda's were consumed with sufficient mass loss where very small fragments were recovered.

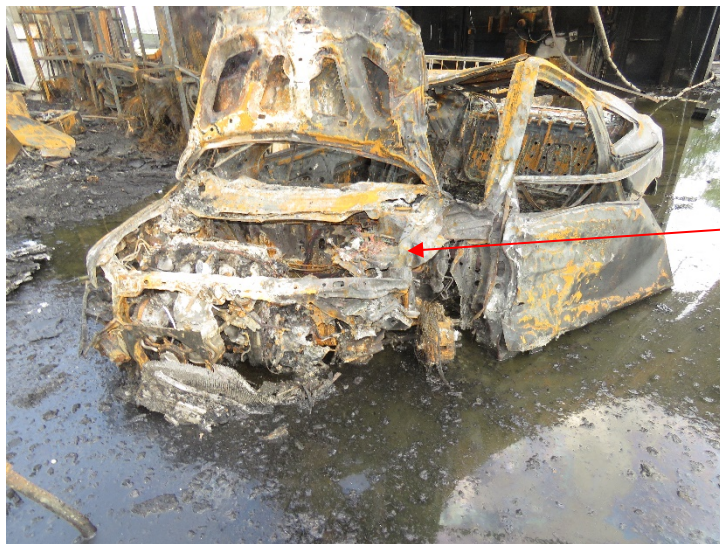
Localized impact surrounding the battery of the vehicle
